# 対策箇所説明図

(その-2)

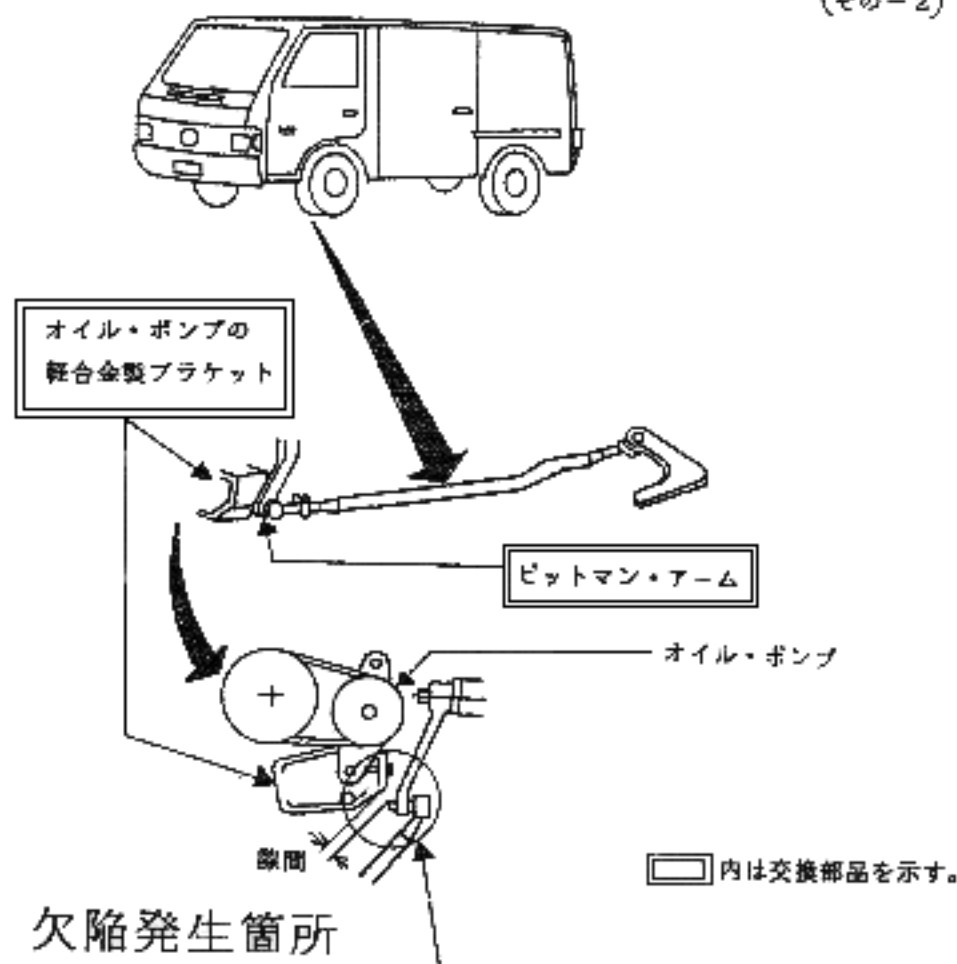
Pitman arm area

Oil pump's aluminum bracket and pitman arm have a very small gap, so they may contact when the handle is cut.

Before countermeasure

Oil pump's aluminum bracket

Pitman arm

After countermeasure

Identify green paint

Countermeasure content

Replace the aluminum bracket of the oil pump and the pitman arm with the countermeasure product.
